# An audit of the surface water outfalls, "Outfall Safari" along the River Pinn

September 2026

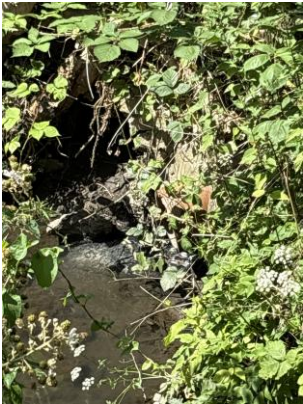
| Survey Number | Location (latitude, longitude) | Bank Side | Thames Water Reference Number | Outfall Score | Image 1 | Image 2 | Image 3 |
|---|---|---|---|---|---|---|---|
| 5 | 51.59865, -0.37763 | Right | N/A | 6 | | | |

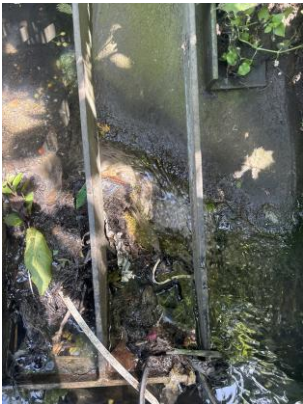
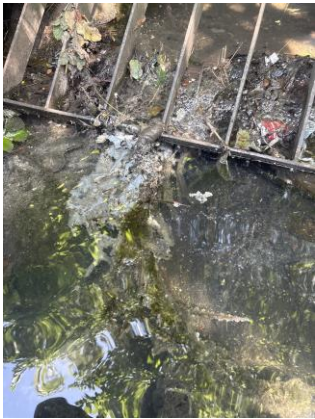
- Survey Number 6: Score 10, Reference number to EA N/A, Reference number to TW 1756000

| Survey Number | Location (latitude, longitude) | Bank Side | Thames Water Reference Number | Outfall Score | Image 1 | Image 2 | Image 3 |
|---|---|---|---|---|---|---|---|
| 6 | 51.60653, -0.36229 | Left | N/A | 10 | | | |

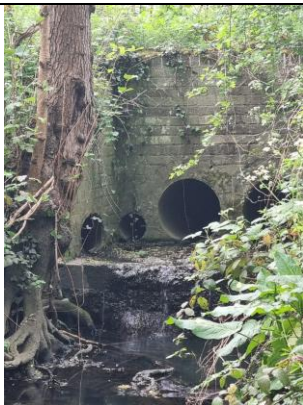
| Survey Number | Location (latitude, longitude) | Bank Side | Thames Water Reference Number | Outfall Score | Image 1 | Image 2 | Image 3 |
|---|---|---|---|---|---|---|---|
| 26 | 51.55983, -0.45861 | Right | N/A | 6 | | | |

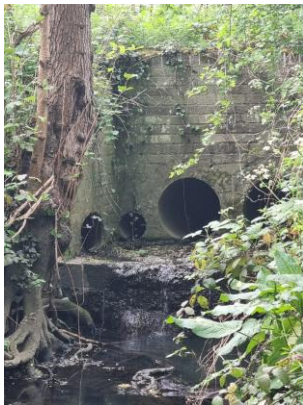
| 27 | 51.55962,<br>-0.45872 | Right | N/A | 6 | | | |

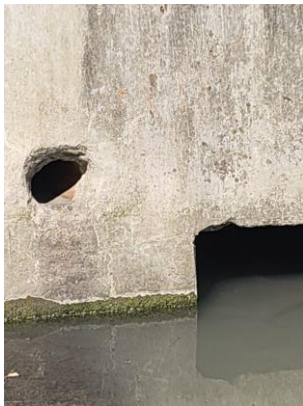
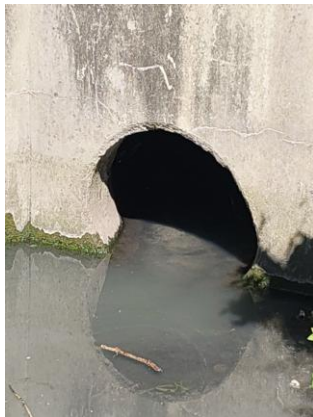
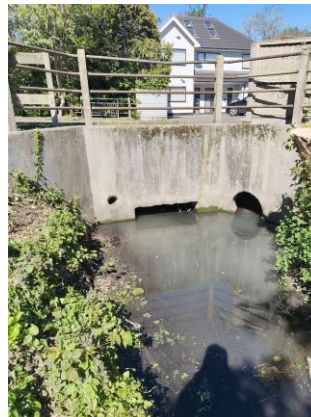
- Survey Number 42: Score 10, Reference number to EA N/A, Reference number to TW 1668204
- Survey Number 60: Score 10, Reference number to EA N/A, Reference number to TW 1668219

| 42 | 51.58448,<br>-0.43947 | Left | N/A | 10 | | | |

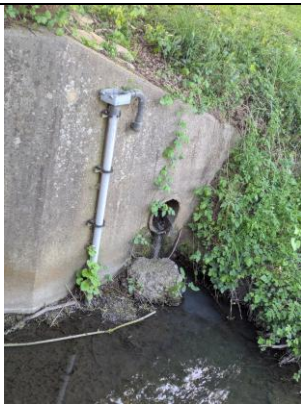
| 58 | 51.56532,<br>-0.45267 | Right | PINN0047 | 8 | | | |

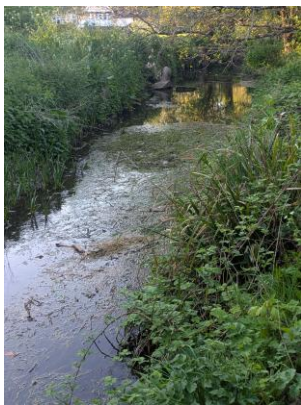
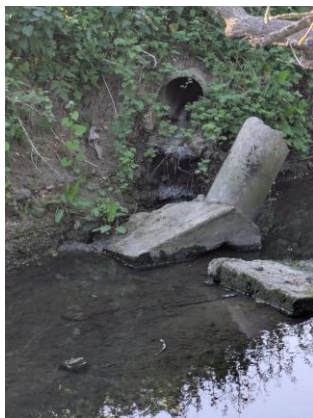
| 60 | 51.56839, -0.4537 | Right | PINN0065 | 10 | | | |

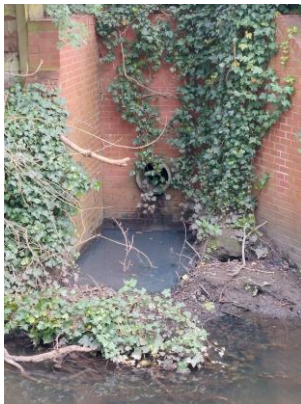
| 96 | 51.53546,<br>-0.47046 | Right | N/A | 8 | | | |

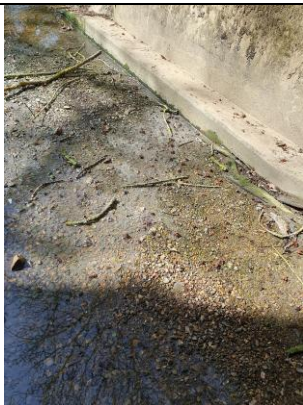
| 96 | 51.53546,<br>-0.47046 | Right | N/A | 8 | | | |
|---|---|---|---|---|---|---|--|
| 117 | 51.58343,<br>-0.41263 | Right | PINN0117 | 8 | | | |

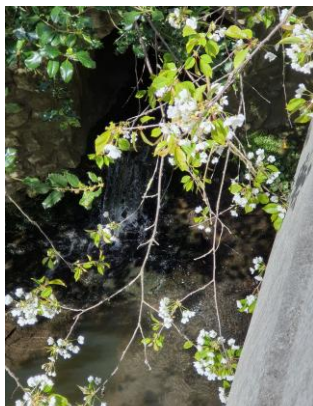
| 127 | 51.58672,<br>-0.40515 | Right | PINN0075 | 6 | | | |
