# An audit of the surface water outfalls, "Outfall Safari" along the Ravensbourne, Quaggy and Pool

September 2026

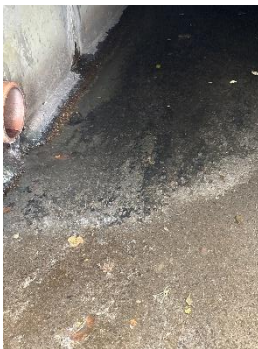
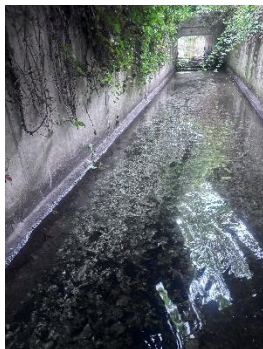
| Survey Number | Location (latitude, longitude) | Bank Side | Thames Water Reference Number | Outfall Score | Image 1 | Image 2 | Image 3 |
|---|---|---|---|---|---|---|---|
| 2 | 51.40906, -0.02868 | Left | N/A | 12 | | | |

- Survey Number 2: Score 12, Reference number to EA N/A, Reference number to TW 1817447
- Survey Number 42: Score 12, Reference number to EA N/A, Reference number to TW 1817447
- Survey Number 188: Score 10, Reference number to EA N/A, Reference number to TW N/A
- Survey Number 212: Score 16, Reference number to EA N/A, Reference number to TW 1645961
- Survey Number 219: Score 10, Reference number to EA N/A, Reference number to TW 1646005
- Survey Number 236: Score 10, Reference number to EA 01623765, Reference number to TW 01623765
