# An audit of the surface water outfalls, "Outfall Safari" along the Upper Brent and Dollis Brook

September 2026

Through systematic surveys of surface water outfalls, signs of pollution can be identified and assessed across a catchment. The resulting data are shared with Thames Water for follow-up assessment and potential inclusion in the Surface Water Outfall Programme (SWOP), as well as with Catchment Partnerships and Environment Agency representatives. This helps to identify and prioritise potentially polluting outfalls for further investigation and action to improve water quality across London's rivers.

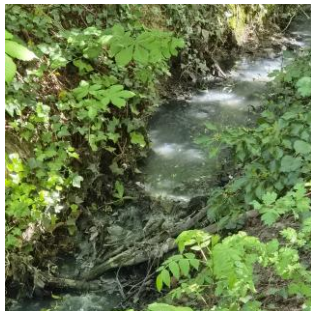
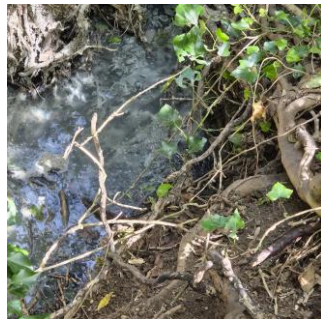
| 77 | 51.63697,<br>-0.17928 | Left | DOLL0088 | 16 | | | |

- Survey Number 77: Score 16, Reference number to EA N/A, Reference number to TW 01656061
- Survey Number 87: Score 10, Reference number to EA N/A, Reference number to TW 01653594

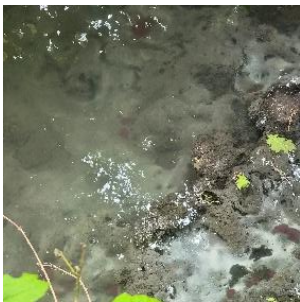
| 97 | 51.63019,<br>-0.18137 | Left | DOLL0085 | 12 | | | |

- Survey Number 97: Score 12, Reference number to EA N/A, Reference number to TW 01649947
- Survey Number 103: Score 10, Reference number to EA N/A, Reference number to TW N/A
