# An audit of the surface water outfalls, "Outfall Safari" along the River Wandle

September 2026

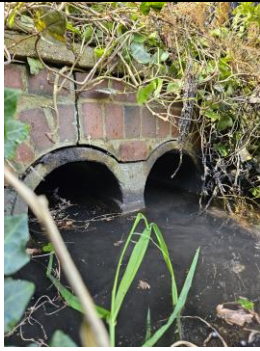
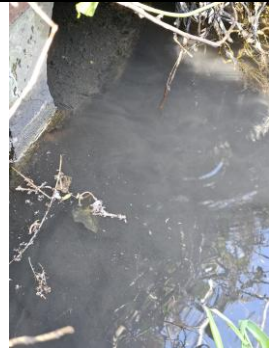
Table 4, Details and photographs of outfalls with an Outfall Safari impact score of  $\geq 6$ .

| 85 | 51.38669,<br>-0.16357 | Left | WNDL009<br>4 | 8 | | | |
